## Gunkholing with Gizmo; Goose Cove, Deer Isle | Issue 101, Boat Show Issue 2008

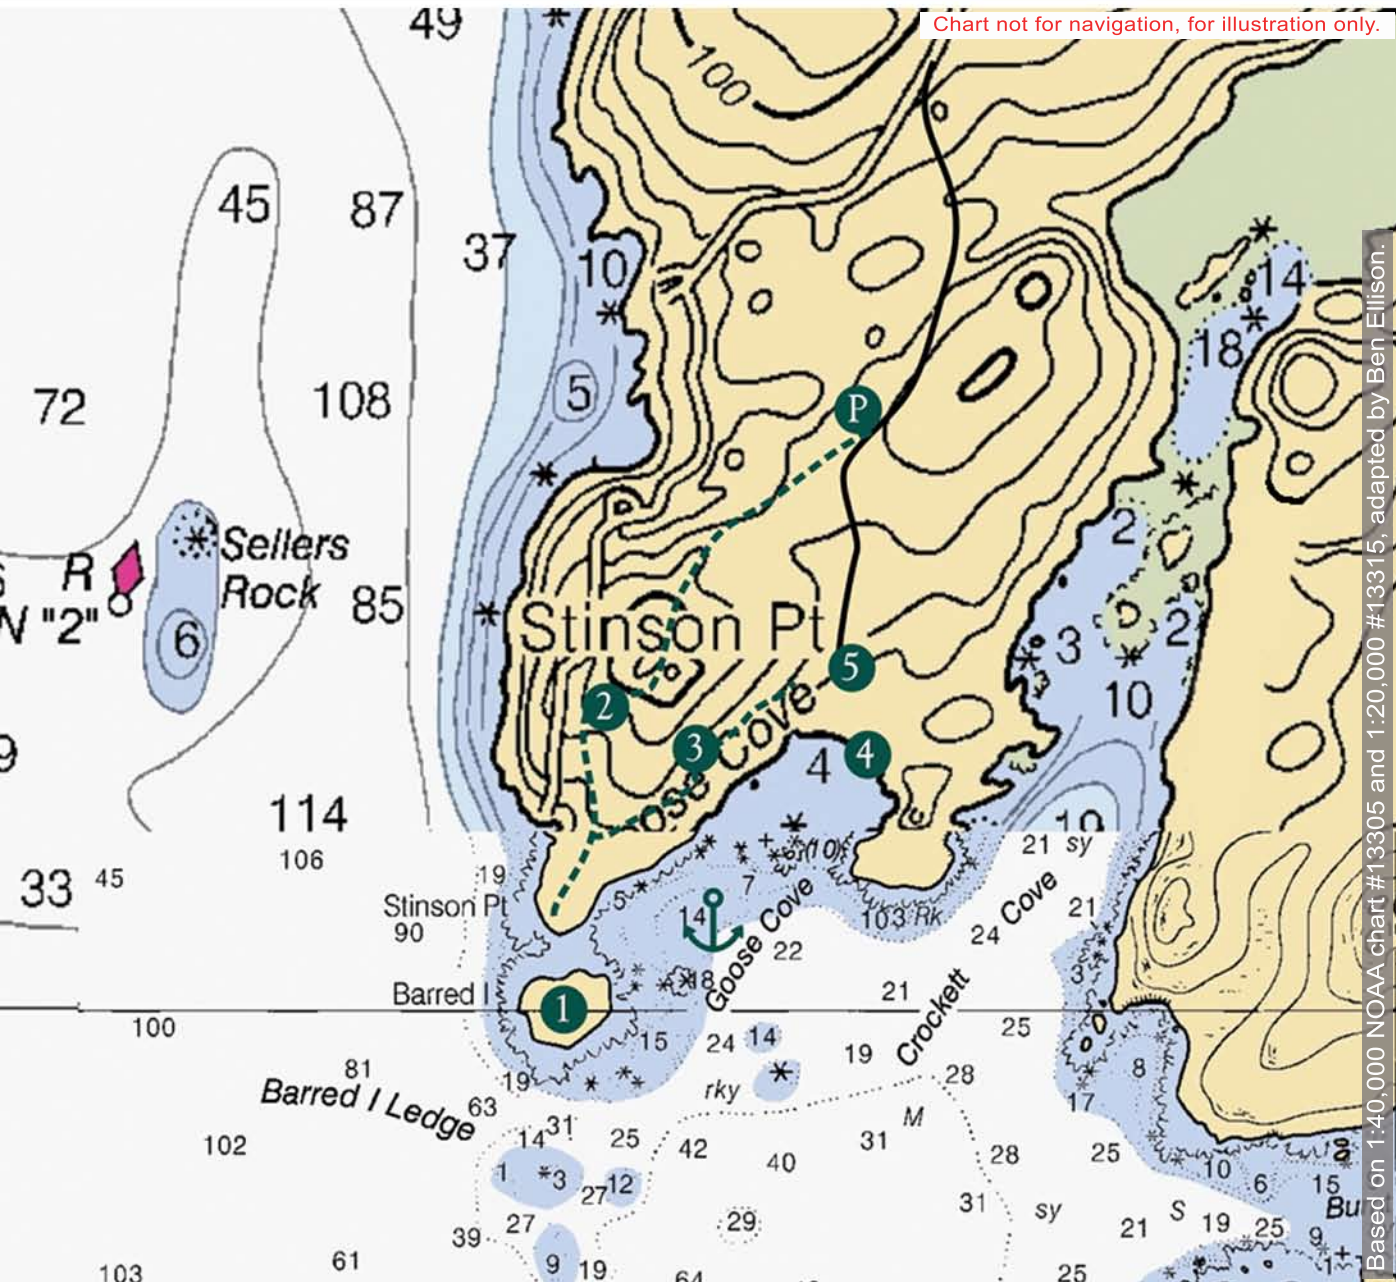
Chart not for navigation, for illustration only.

- 1 --- Nature Conservancy's Barred Island Preserve
- 2 --- Barred Island Preserve, main trail.
- 3 --- Goose Cove Lodge / High Shore Trail.
- 4 --- One of the best beaches in the region.
- 5 --- Cockatoo II Portuguese Seafood Restaurant (207-348-2300)

Here are some further notes on anchoring in Goose Cove: First of all, note all the "obstructions that cover"---i.e. the asterisks marking rocks that show some time between low and high tide. Even at close to a normal low tide, I could not see the one marked "Barred I Ledge" or the other outer one to the right of the "rky" bottom notation. On the other hand, the ledge at the entrance to the inner cove is not as high as it's shown. The small yellow area with the "(10)" notation is, I think, a chart error. That symbolism indicates something that does not cover at high tide and in fact is 10' higher than a normal high tide. But this ledge does cover some times, so I believe that it is 10 feet above the average LOW tide.

At any rate, where I've put the anchor is the safer spot to get to, but I did in fact comfortably anchor north of the big, usually visible ledge, entering on the East side. It's too bad that the higher detail chart doesn't quite extend into that area, but is bigger and deeper than it looks. GPS plotting on NOAA raster charts like these, as well as C-Map charts, seemed to accurately guide me amongst the hazards. But of course I can take no responsibility for anyone else's experience in this gunkhole! Take care, and report back, please at: [www.maineboats.com/coastal-adventures/gizmo-101](http://www.maineboats.com/coastal-adventures/gizmo-101).
